Lower Colorado River Multi-Species Conservation Program

Hart Mine Marsh

2013 Annual Report

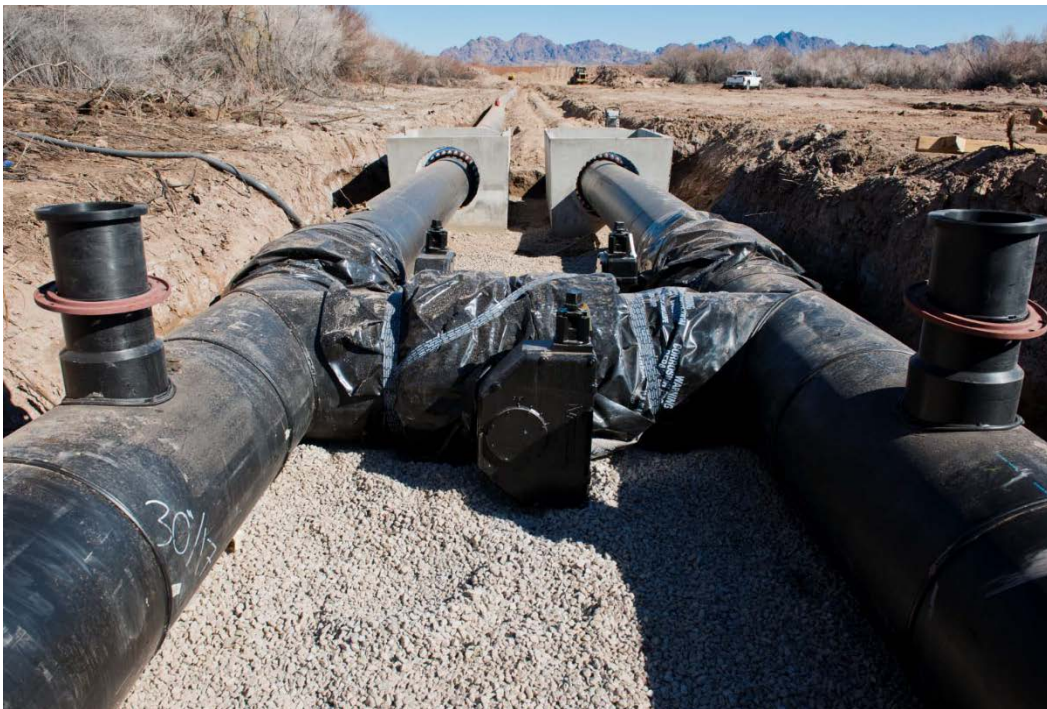
Figure 6.—Ground photo of HMM pipeline replacement in the spring of 2013.

Major infrastructure repair activities were completed in FY13 and involved the replacement of the leaking water delivery lines from the Unit 2 pumps and the installation of a dedicated water line for HMM (figures 5 and 6). An additional water inlet was also constructed in the northwestern corner of cell 1 to allow pumped (unmixed with drain water) Colorado River water into cell 1 via the Unit 2 irrigation infrastructure. This addition was part of the original plan for HMM; however, due to time and resource constraints, it was not implemented during previous construction phases. The combination of this water inlet and the other upgrades to the water delivery infrastructure at HMM has increased efficiency and flexibility at HMM in terms of water management.

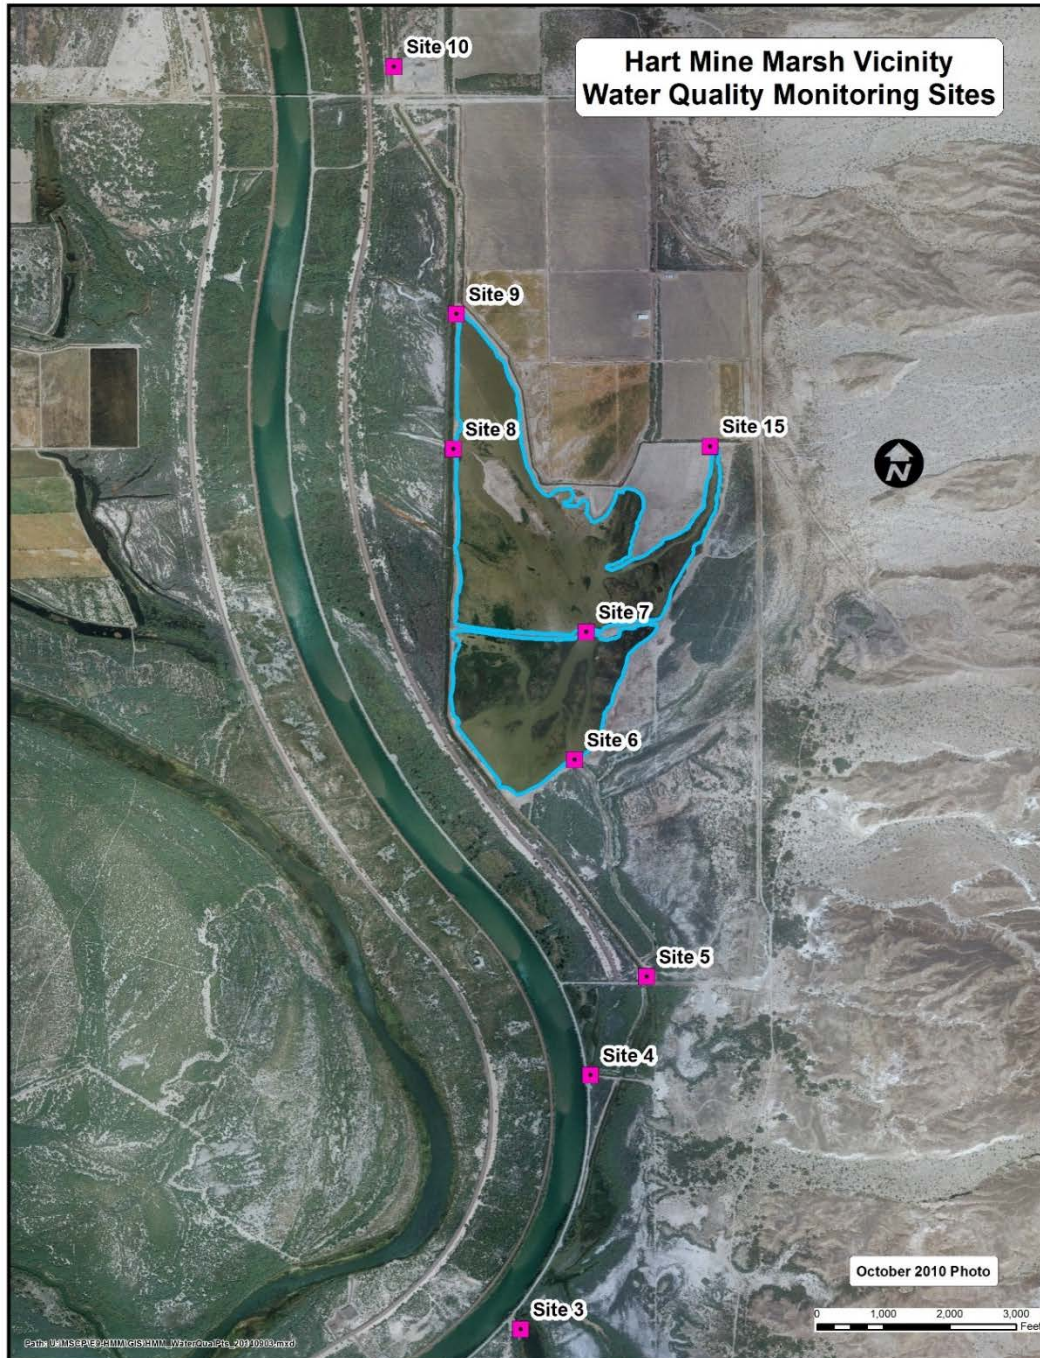
Figure 8.—HMM vicinity – water quality monitoring sites, FY13.

Water quality parameters, including dissolved oxygen (DO), specific conductivity (SpCond), and pH (potential of hydrogen), were measured from October 25, 2012, through September 24, 2013. Figure 8 shows the locations (sites) where water quality parameters were measured. In general, water quality varied from site to site and across seasons. Bar graphs that depict the average values for each parameter across the sites relevant to HMM (sites 6–10 and site 15) can be found on figures 9–11. An additional monitoring site (site 15) was added in late FY12 in order to be more representative of the northeastern section of the marsh.
